**THE CHARACTERIZATION AND ANALYSIS OF ORNAMENTAL
CAST STONE AND STUCCO FROM THE PALACIO ERRÁZURIZ,
BUENOS AIRES, ARGENTINA**

James Valente Banta

A THESIS

Historic Preservation

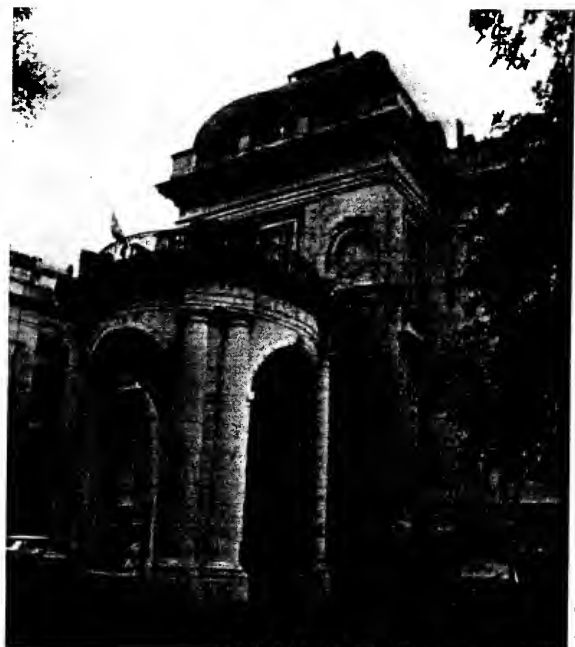
The tholos of the east entrance is over-painted up to the cornice. As this facade is in the worst condition, removal of the over paint will likely expose bad repairs as well as deterioration and damage. Test treatments are recommended for steam, abrasive, and

chemical paint stripping and cleaning of the entrance. The conditions visible now are abrasion and impact loss, delamination and scaling, as well as irregular loss of partial paint layers due to water penetration.

Illustration 7. Palacio Errazuriz,
east entrance and porte-cochere
(view from the northeast).

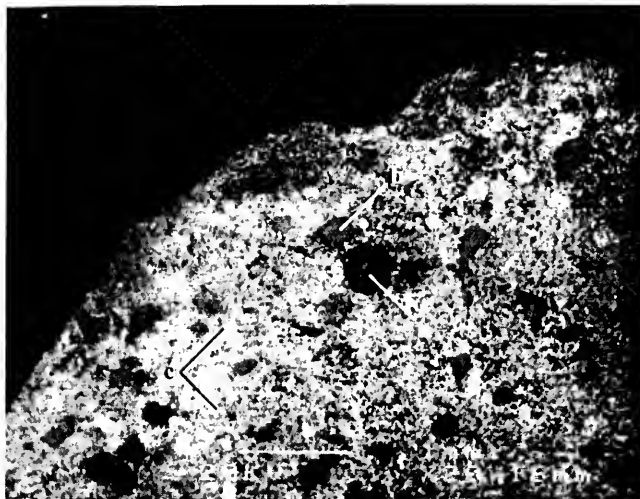
Illustration 20. Sample ER 1, SEM/EDX back scatter electron image in cross section. Note vacuole from casting process (a), aggregate (b), and paste (c).

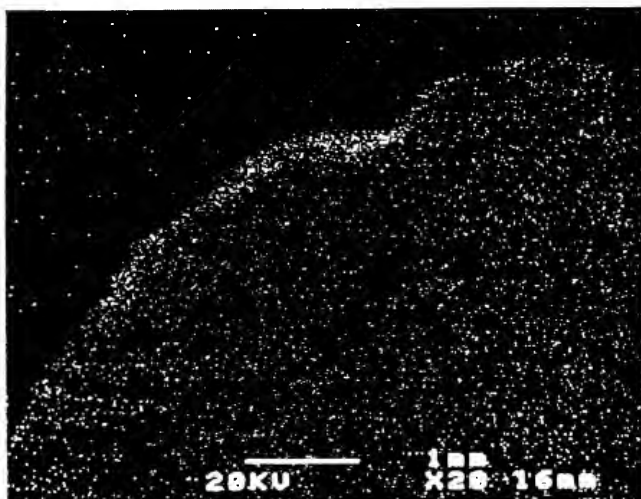
The presence of a sulfur rich crust on samples ER 1 and ER 2 probably indicates the effects of pollution. (see Illustrations 20, 21, 22, and 23) Sulfur in the atmosphere from industrial production combines with moisture in the atmosphere to react with carbonate-rich masonry and forms sulfate crusts. These sulfur-rich surface layers may also be evidence of a gypsum (calcium sulfate) finish or the presence of bacterial action, but the location from which samples ER 1 and ER 2 were taken suggest another theory.

Illustration 21. Sample ER 1, SEM/EDX sulfur mapping in cross section showing sulfur-rich surface.

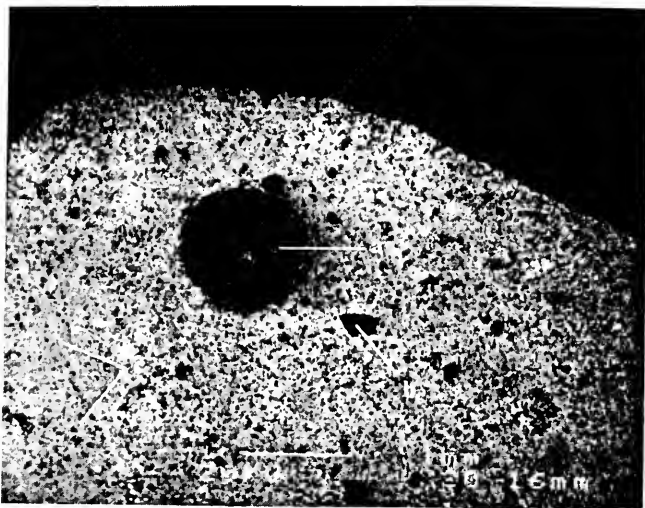
Illustration 22. Sample ER 2, SEM/EDX back scatter electron image in cross section. Note large vacuole from casting process (a), aggregate (b), and paste (c).

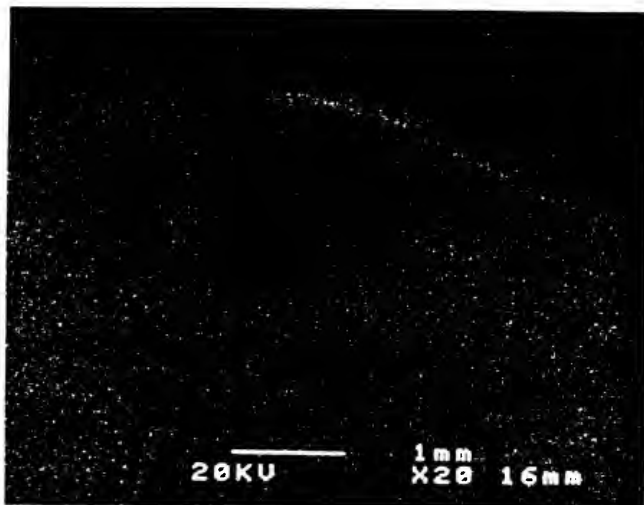
Illustration 23. Sample ER 2, SEM/EDX sulfur mapping in cross section showing sulfur-rich surface.

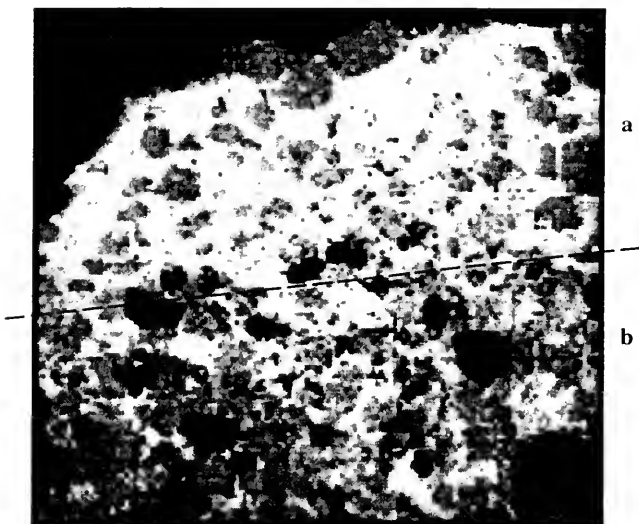
Illustration 24. Sample ER 28, SEM/EDX back scatter electron image in cross section. Note the finish layer (a) and the base coat (b) of the stucco.
